Dredging Project History

Background

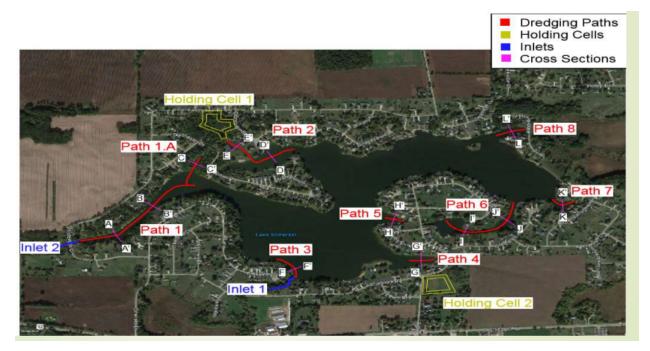
The dredging project consisted of 8 main "paths" as noted on the map below:

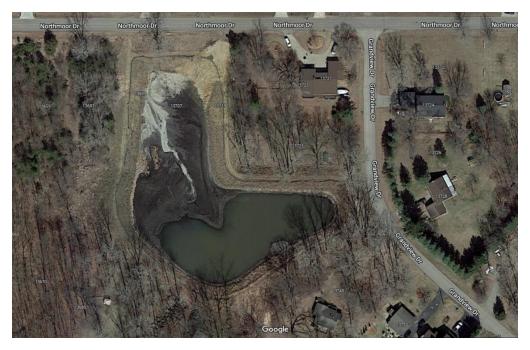
A closer look illustrates the size of the pits in closer detail. Below is the Northmoor pit site.

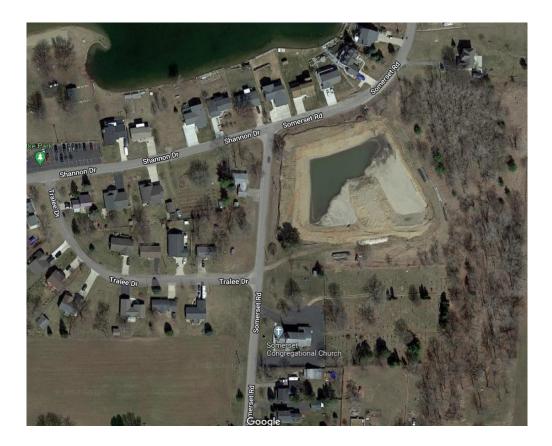
Below is the Congregational Church depositing site.

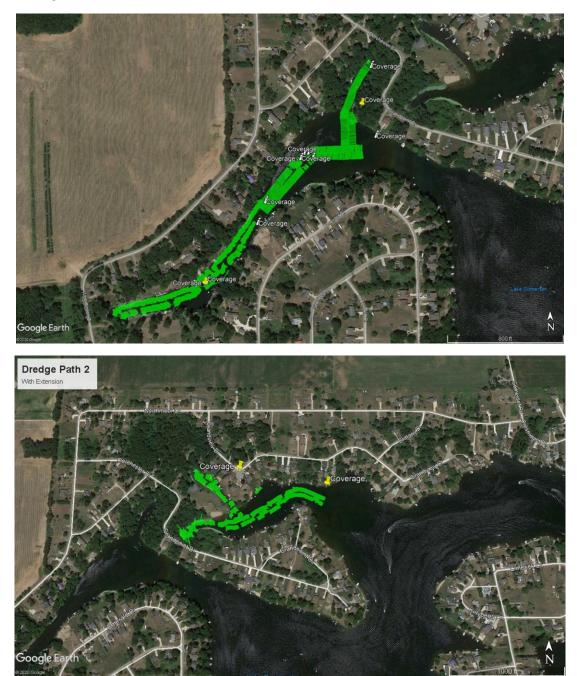
Dredge Path 1 and 1A

The paths and completed dredging were summarized in Google maps with GPS coordinates provided to the membership periodically. The resulting maps displayed below were published at the end of the project.
